**Automated  
Inspection of  
Concrete Ties:  
Identifying Indications of  
Rail Seat Deterioration**

RMSS White Paper Series

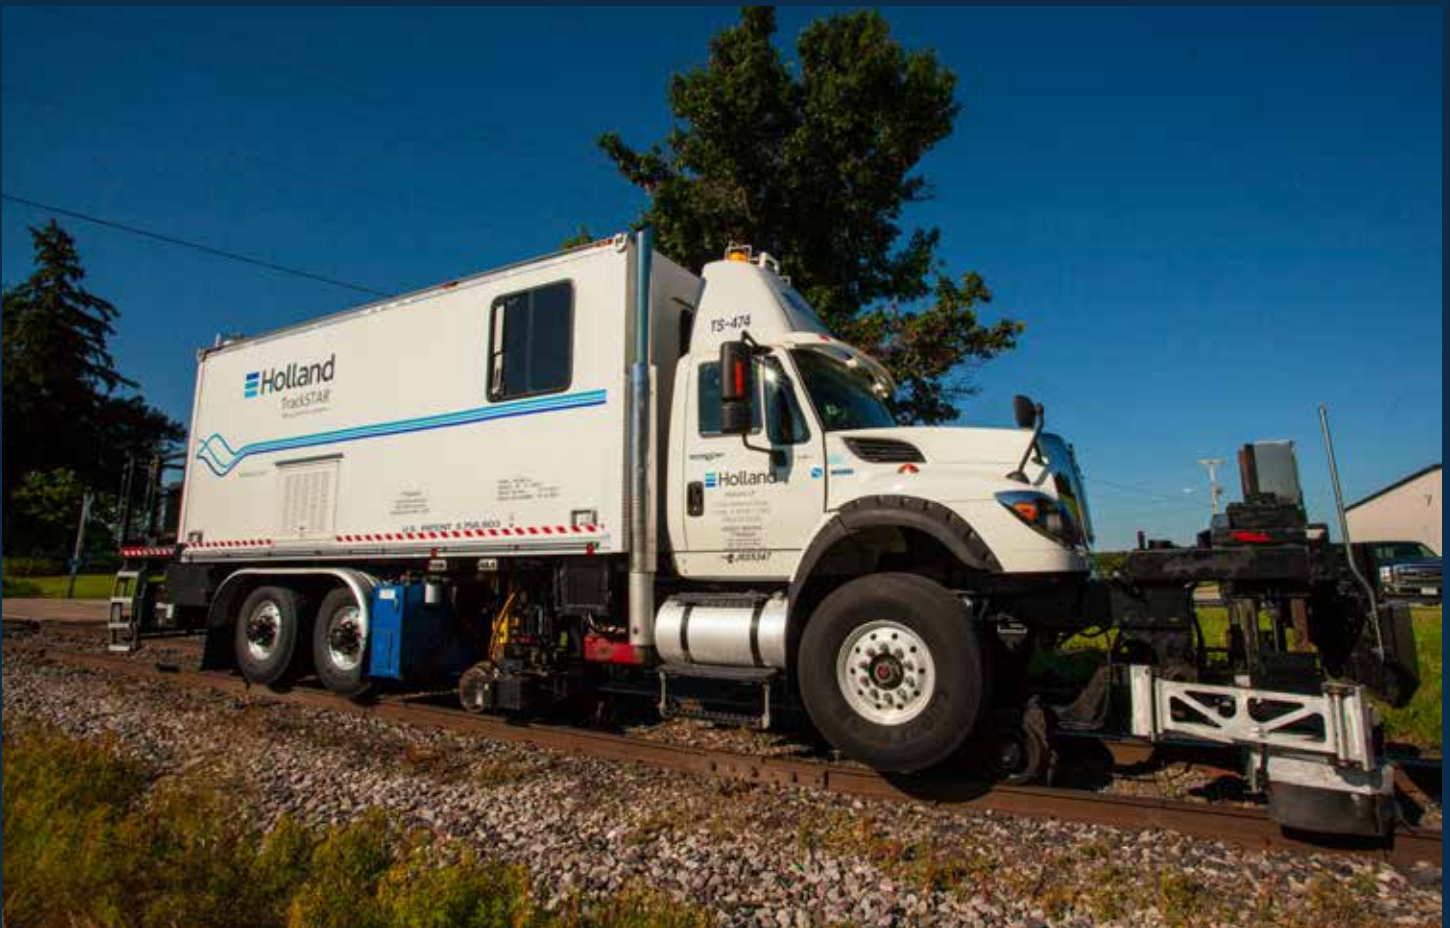
A TrackSTAR® unit equipped with Gauge Restraint Measurement System.

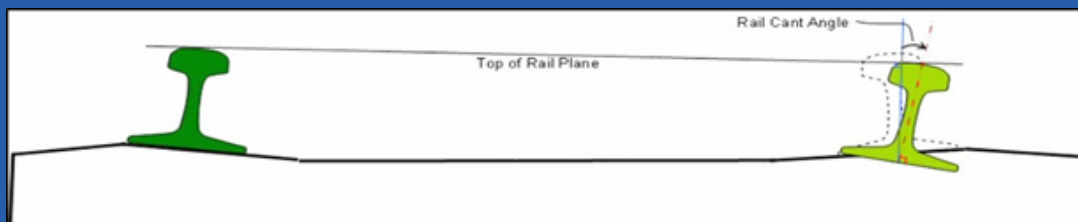
Figure 2. Rail cant is reported in degrees as an angular variance from perpendicular to a line through the apex of both rails.

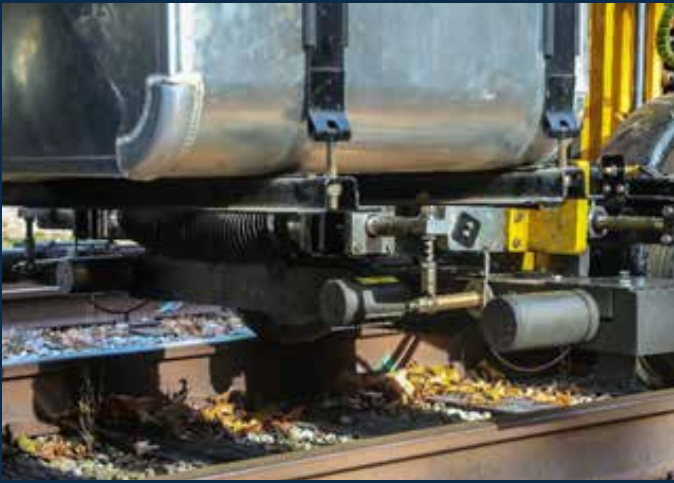
TrackSTAR® Gauge Restraint Measurement System is capable of detecting Rail Seat Deterioration through loaded cant measurement.

Holland TrackSTAR® systems measure track geometry, rail wear, track gauge strength, rail cant, and other parameters that can provide indications of RSD. Holland's patented split-load-axle technology (Figure 3) provides quantifiable assessment of (loaded, unloaded and delta) cant and gauge, the primary indicators of RSD in GRMS-type measurement. Delta cant (the difference between loaded and unloaded) is determined from two measurements — an unloaded measurement taken at the front of the vehicle, and a loaded measurement taken at the split loading axle, which delivers a constant, nondestructive, vertical and lateral load that effectively identifies the weakest track locations. Cant and gauge are measured in one-foot increments, providing real-time exception reporting to identify locations where gauge or cant (rail rotation), exceed thresholds, an indicator of RSD in concrete ties.

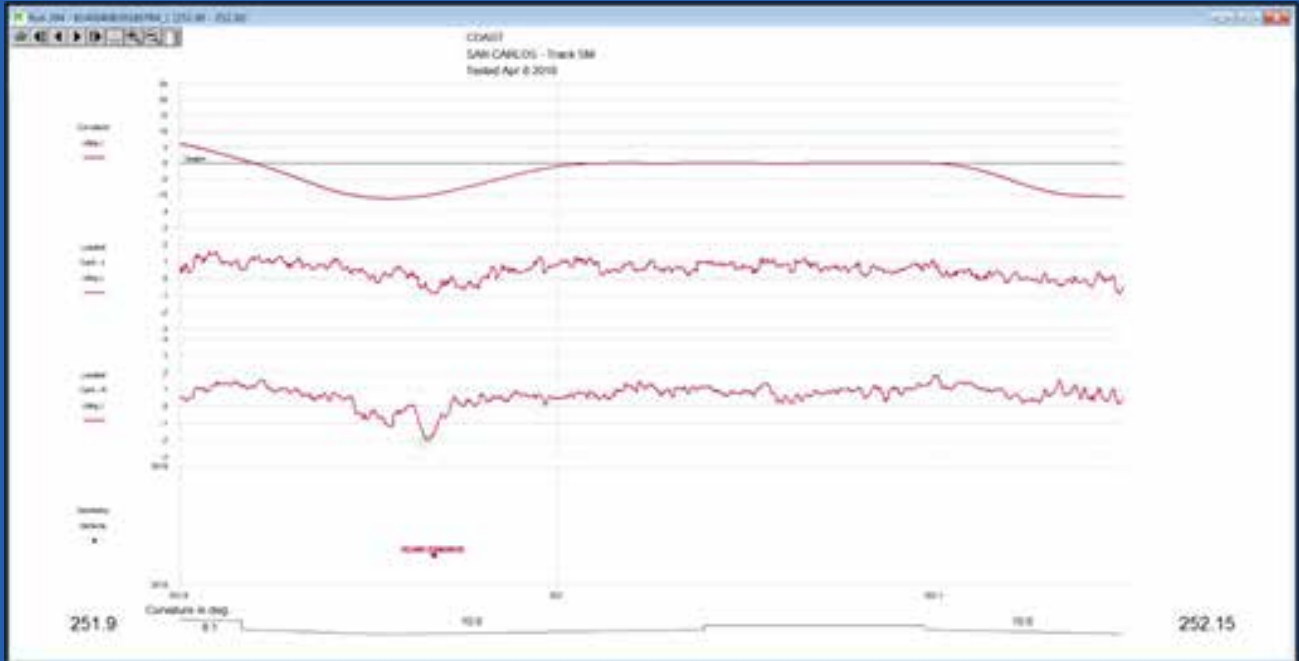
Rangecam® track condition reports can be scaled to provide context to RSD (and other) data.

The same information is shown on a strip chart in Rangecam® below. Holland's Track Analyst software, provides context, with the ability to view the data over a variable scale (¼ mile, in this example).

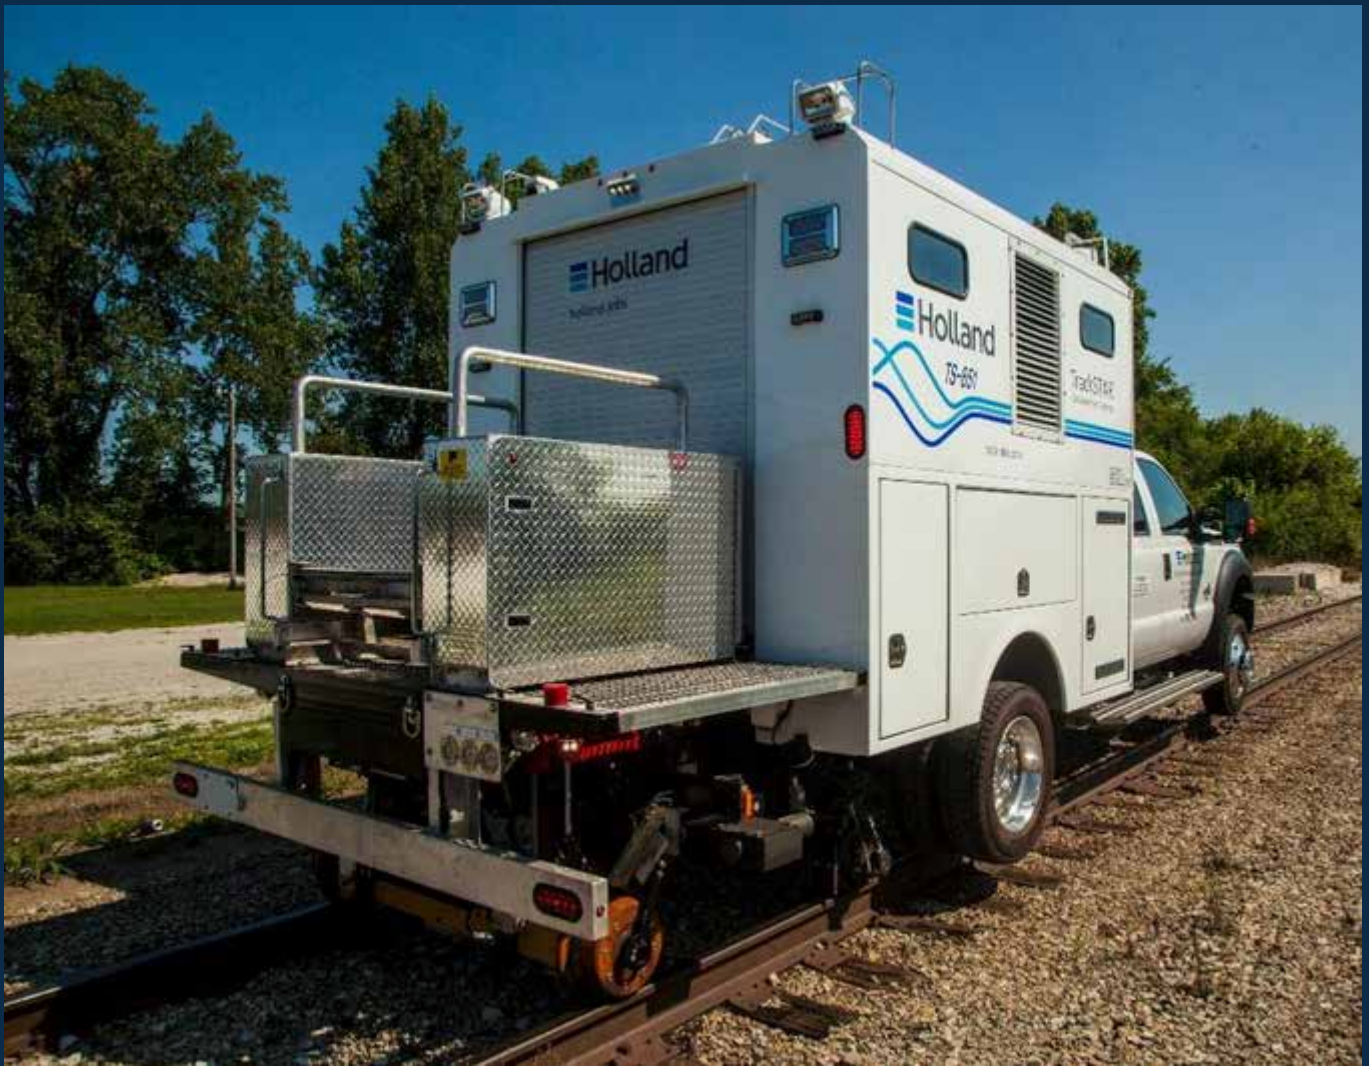
800-series TrackSTAR® vehicle

Holland's fleet of track testing vehicles are designed to satisfy the track geometry and rail profile measurement requirements of Class 1, Regional, Short Line, and Transit properties in North America.
